NEW ECOLOGY

# Achieving Deeper Energy Retrofits with Philadelphia's Built to Last Program

February 2026

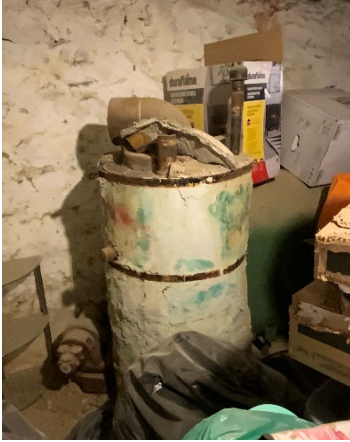
A disconnected water heater wrapped in asbestos.

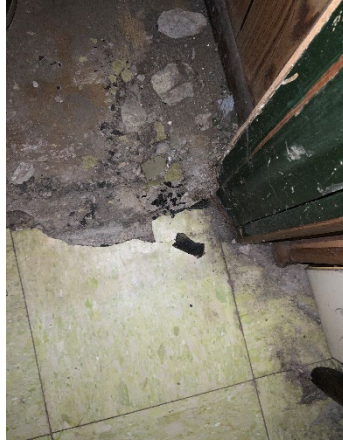
Cracked floor tile in a basement, likely containing asbestos.

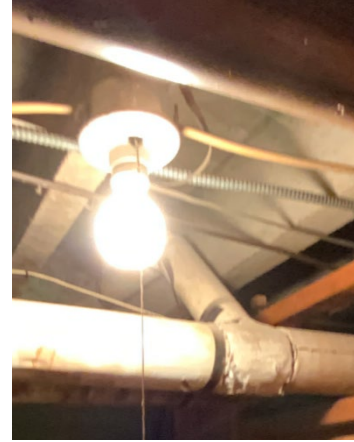
Asbestos pipe insulation on basement boiler pipes.

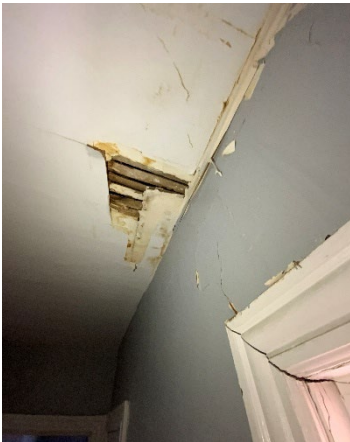
Ceiling damage from a leaking roof.

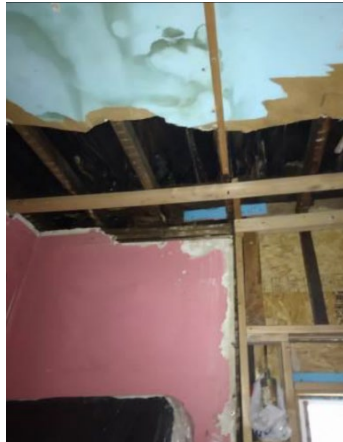
Ceiling damage from a leaking roof.

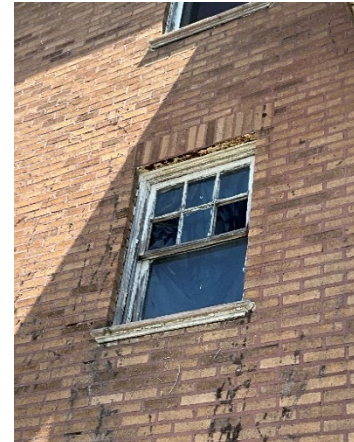
Broken window with deteriorated paint trim.

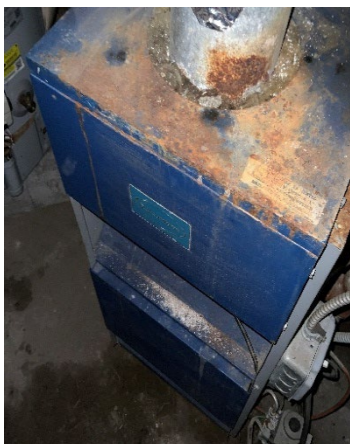
A deteriorated boiler at the end of its useful life.

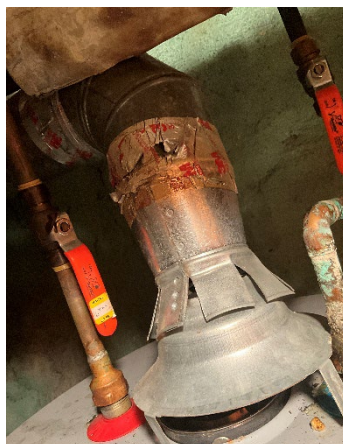
A dangerous, improvised solution to a disconnected water heater flue.

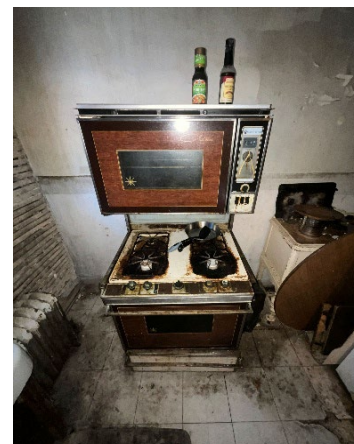
A deteriorated range still in use in a BTL home.

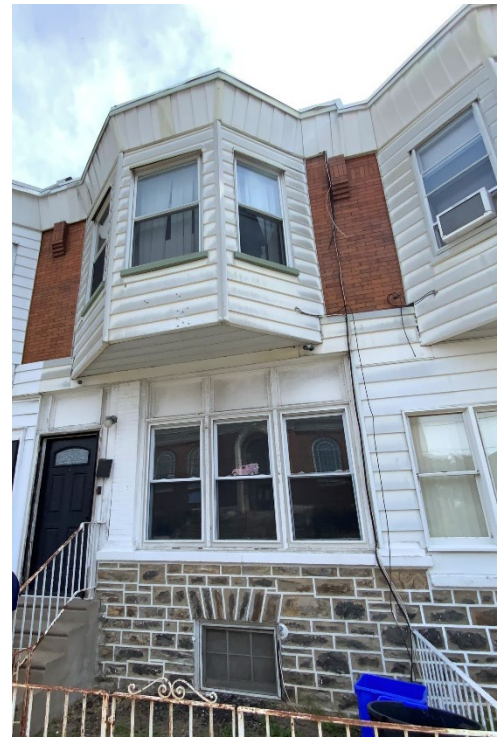
Framed walls in these homes are usually in the front or rear of the home and enclose architectural bump outs, enclosed porches, or rear additions. Figure 8 shows a front bump out on the second floor of a home and a porch under the 2<sup>nd</sup> floor that has been enclosed to bring that area into the conditioned area of the house. The framed walls in these areas likely contain little to no insulation. The depth of the wood framed cavities varies, and the number of framing members often creates challenges when considering filling these cavities with insulation. Another complication when attempting to insulate is old wiring that may be located in these cavities. The replacement of knob and tube wiring or other electrical hazards may be necessary before any wall insulation can be installed.

*Figure 8: A 2nd floor bump out and framed in porch. Areas with white siding likely hide wood framed walls.*

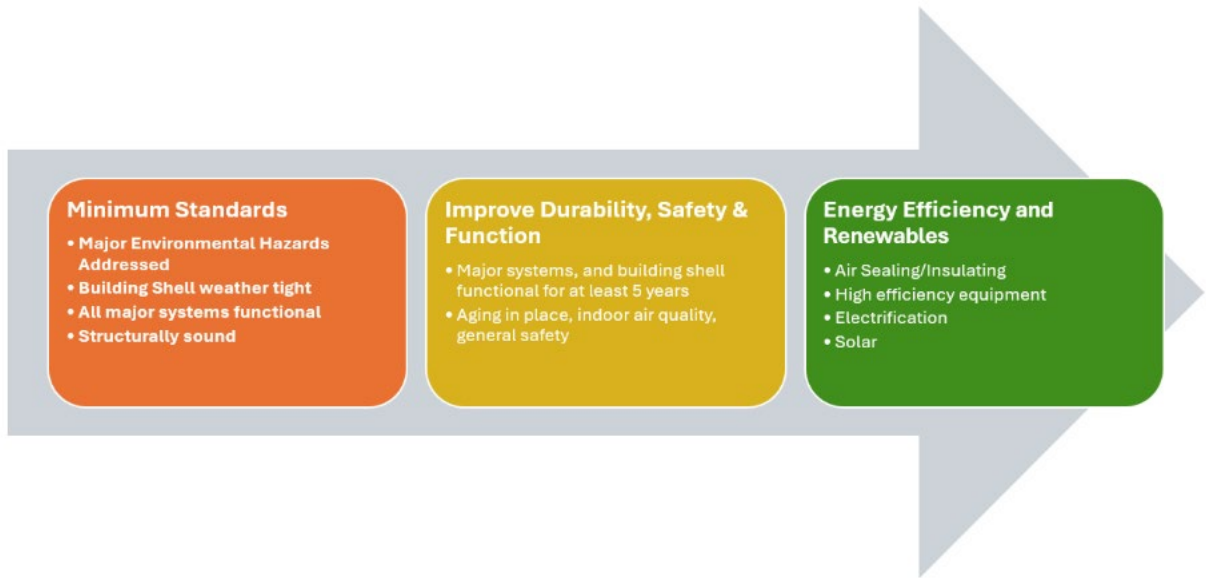
Built to Last evaluates homes using a home condition continuum (Figure 11) which focuses on basic standards of living first, then moves to durability, safety, and function. When those elements of the building are addressed, the program then focuses on energy efficiency and renewables.

*Figure 11: Illustration of the home condition continuum concept. See Appendix A for the expanded home condition continuum.*

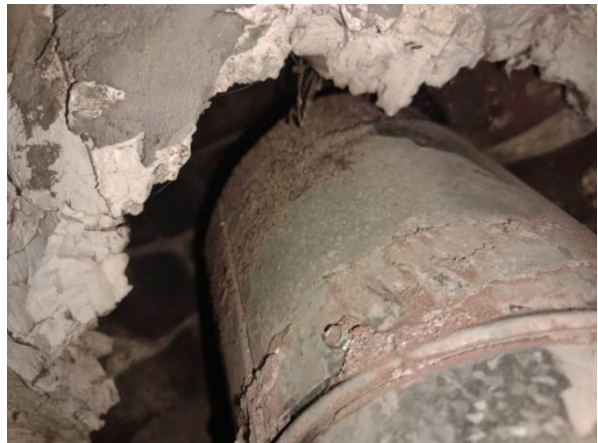
Electrifying water heating saves energy and negates the need for a chimney/ flue liner. The cost of a flue liner is estimated at \$2,800. Hybrid HPWH have especially high energy savings and even with the current higher cost of electric energy per unit than natural gas, it is rare that these units will increase utility costs for the resident. Figure 14 graphs the estimated costs to install 4 different types of replacement water heating equipment and shows the efficiency range available for that type of equipment. Hybrid heat

*Figure 32: A flue terminating into a masonry chimney with no chimney liner.*

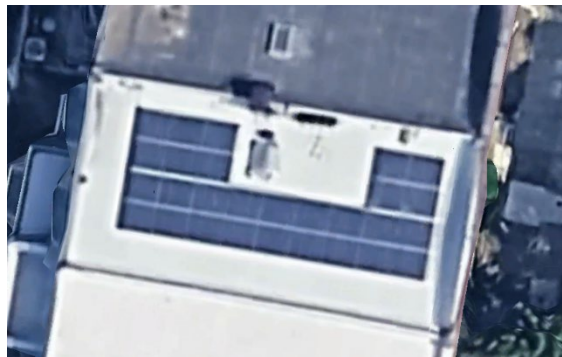
*Figure 36: Google Earth Image of Solar Array on the roof of the property.*
